HARDLOCK[®]

Self-Locking Nut

HARDLOCK Nut (HLN)

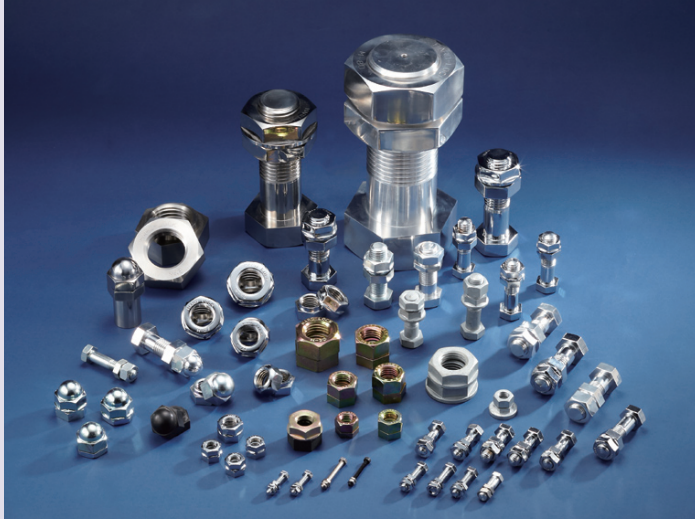
The Globally Recognized HARDLOCK Nut

Utilizing the wedge principle used in ancient Japanese architecture, the HLN is the ultimate self-locking nut which perfectly succeeds to integrate the nuts with the bolt.

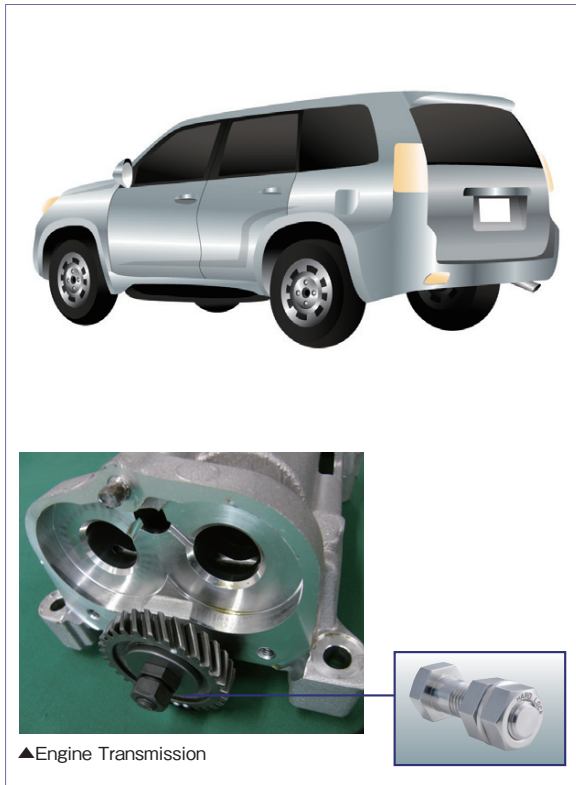
HLN SUV Engine Transmission

- Flanged Nuts were utilized in the engine transmissions of SUVs
- Loosening of nuts occurred frequently when starting the engine and many SUVs had to be recalled.

Major Loosening Cause

- Loosening due to cyclic stress in the rotational direction of the bolts axis

- By switching from Flanged Nuts to HARDLOCK Nuts the loosening problem was resolved.
- By utilizing HARDLOCK Nut the loosening occurring when starting the engine were also resolved.

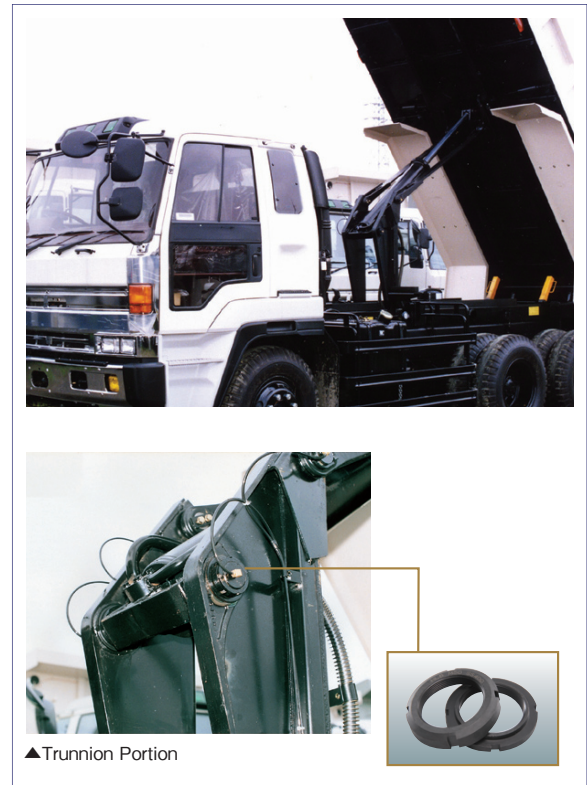
HLB Specially equipped vehicle trunnion fixing

- Double bearing nuts were used as a countermeasure for loosening
- The double bearing nuts were tightened by the "double nut method". However, loosening occurred due to the variation in tightening force.

Major Loosening Cause

- Loosening due to cyclic stress in the rotational direction of the bolt axis

- By adopting the HARDLOCK Bearing Nut, the workability was improved and the loosening problem was solved.
- By switching to HARDLOCK Nut, the maintenance costs were significantly reduced

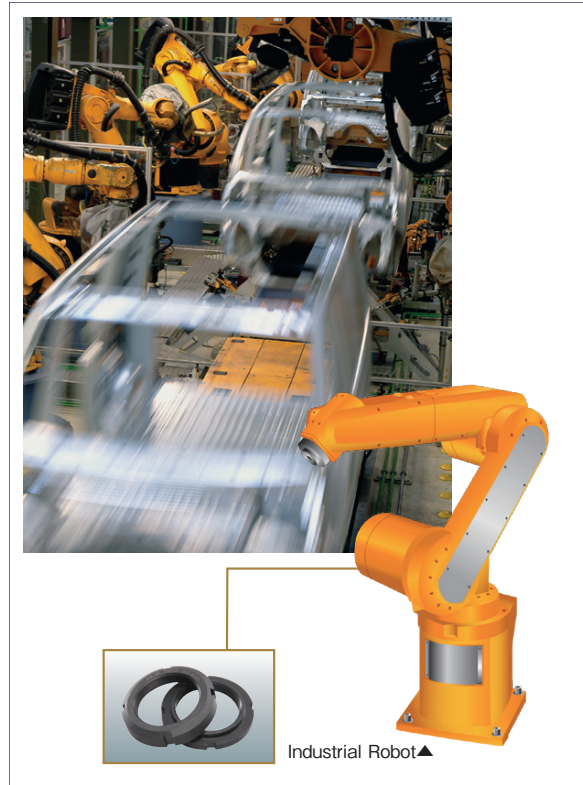
HLB Industrial Robot Arm Joint

- Prevailing torque type self-locking nuts where used were in the arm portion, but iron powder produced by the friction between the nut and shaft caused poor movability.
- Torque control was difficult with prevailing torque type self-locking nuts and there was a problem with variety in axial force.

Major Loosening Cause

- Loosening due to cyclic stress in the rotational direction of the bolt axis

- By switching to HARDLOCK Bearing Nut the problem with shaft damage was resolved.
- Axial force management by proper torque combined with elimination of loosening improved the product performance of the industrial robots.

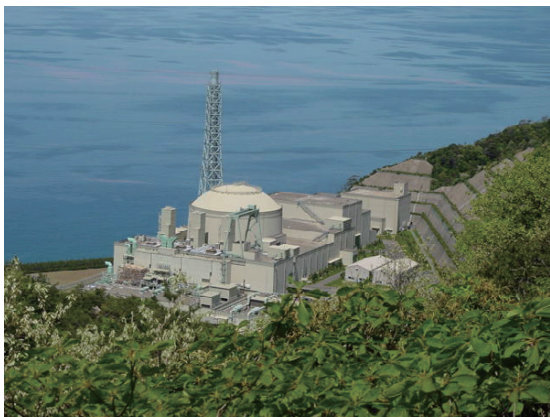
▼Piping Support

- Double nuts were used in the fixed stand of the reactor core and piping supports in the power plant. Retightening work and maintenance were required on a daily basis due to frequent loosening.
- Since nuclear power plants are large in size and places where nuts are used are plenty, huge amounts of maintenance cost and maintenance time was necessary.

Major Loosening Causes

- Loosening due to micro-motion abrasion
- Loosening due to thermal causes

- HARDLOCK Nut demonstrated superior self-locking performance and prevention of loosening.
- Safety in the nuclear power plant facilities increased, time spent on maintenance and maintenance cost was reduced immensely.

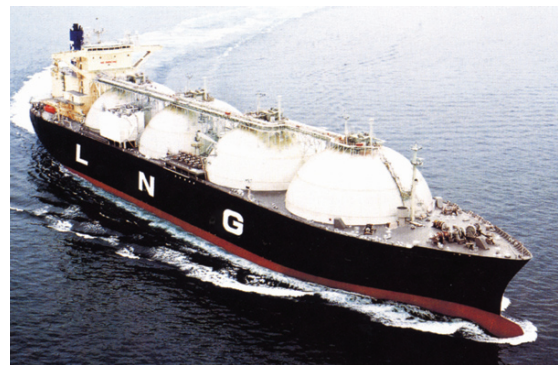
▼Ship Engine

- Double nuts were used on the internal combustion engines of the ship, loosening due to thermal expansion and severe vibration occurred on a daily basis.
- Retightening work had to be made frequently and an enormous amount of time and cost was spent on maintenance.

Major Loosening Causes

- Loosening due to micro-motion abrasion
- Loosening due to cyclic stress in the direction perpendicular to the bolt axis
- Loosening due to thermal expansion

- By switching to HARDLOCK Nut with special coating, Loosening due to vibration and/or thermal expansion was eliminated.
- Significant reduction in maintenance cost as well as retightening work.

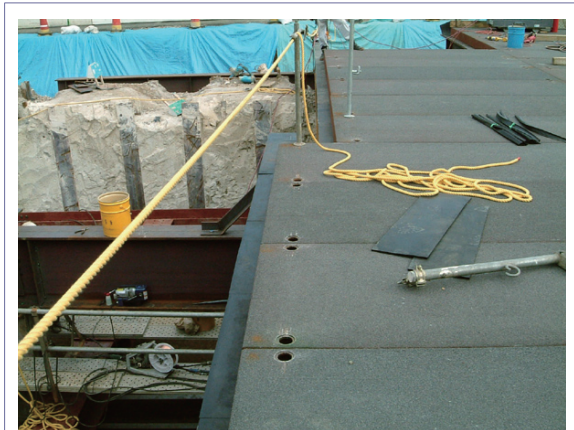
▲Road Plates

- Countermeasures such as welding and insertion of cushioning materials to reduce vibration in the road plates were carried out. However, due to poor welding and replacement of cushioning material work, both options were unsatisfactory.
- Another serious problem was the noise control due to collision of the road plates when vehicles passed over them.

Major Loosening Cause

- Loosening due to cyclic stress in the direction perpendicular to the bolt axis

- By switching to HARDLOCK Nut in the connection portion of the road plates, problems such as loosening were eliminated.
- Additionally, the noise generated when vehicles pass over the road plates was eliminated and overall costs were reduced.

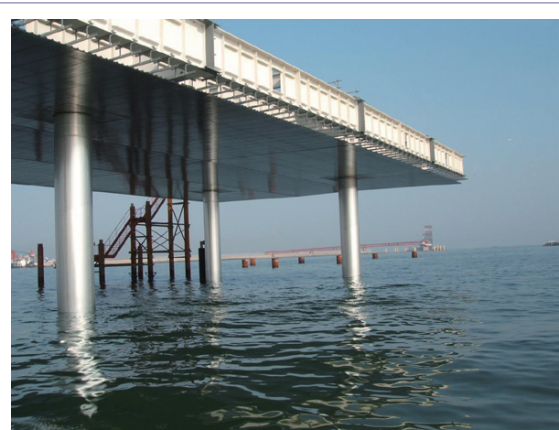
◀ Pier Cover Plate Mounting

- During the construction of the titanium panel on artificial grounds rear surface of the offshore airport, prevailing torque self-locking nuts were studied.
- Since the prevailing torque type self-locking nuts caused scratches on the bolt (peeling off the plating), rust occurrence was a serious problem and concerns regarding safety and corrosion resistance arose.

- Loosening due to micro-motion abrasion
- Loosening due to cyclic stress in the direction of the bolt axis

- By switching from prevailing torque type self-locking nuts to HARDLOCK Nuts, problems related to bolt damage and corrosion were eliminated.
- Loosening due to severe vibration in the pier cover plates during landing and take-off of aircrafts were eliminated, HARDLOCK Nut also corresponded to the 100 year warranty requested by the Ministry of Land, Infrastructure and Transport.

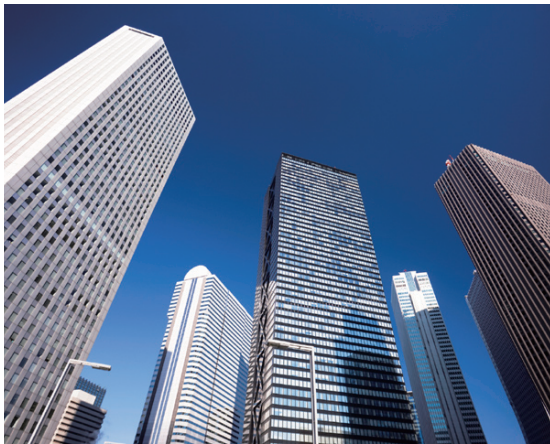
HLN Exterior Wall of High-rise Buildings

- Aluminum curtain walls were mounted on the exterior walls of high-rise buildings with metallic fastener, but due to the high torque required to tighten the metallic fasteners, it caused expansion of the aluminum which would cause a specific sound.

Major Loosening Causes

- Loosening due to cyclic stress in the direction perpendicular to the bolts axis
- Loosening due to thermal causes

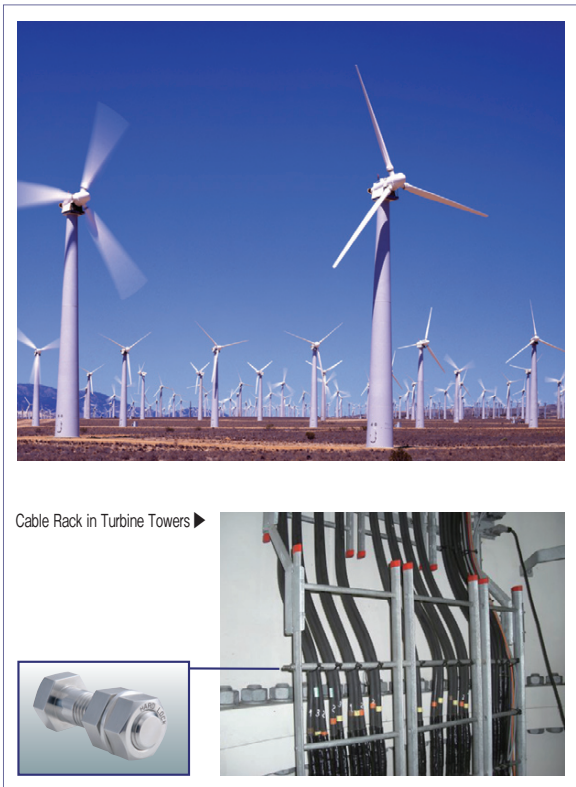
HLN Transmission Equipment in Wind Turbine Towers

- Wind turbine towers are installed in areas where there are strong winds, due to the irregular stress induced by strong winds, common double nuts and/or spring washers were not able to produce significant locking effect and eliminate loosening.
- Nylon nuts were used in the fastening portions of wiring cable racks, ladders etc. inside of wind turbine towers, however, due to the vibration caused by the rotation of the blades (wings) the Nylon nuts became loose on a regular basis.

Major Loosening Causes

- Loosening due to cyclic stress in the direction perpendicular to the bolt axis
- Loosening due to micro-motion abrasion

- By switching to HARDLOCK Nut, due to successful axial force control and proper torque, loosening was eliminated.
- Regular maintenance work and equipment maintenance cost was significantly reduced.

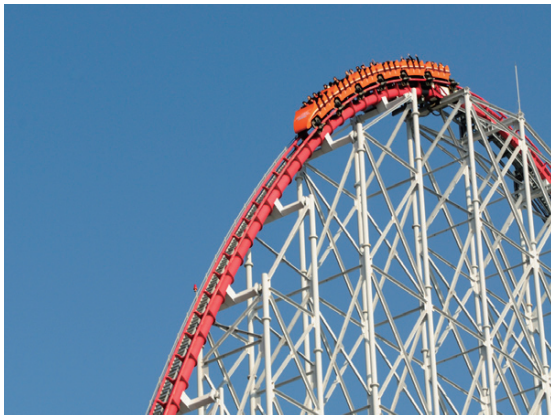
HLB Roller Coaster Wheel Axis Stopper

Major Loosening Causes

- Loosening due to cyclic stress in the rotational direction of the bolt axis
- Loosening due to cyclic stress in the direction of the bolt axis

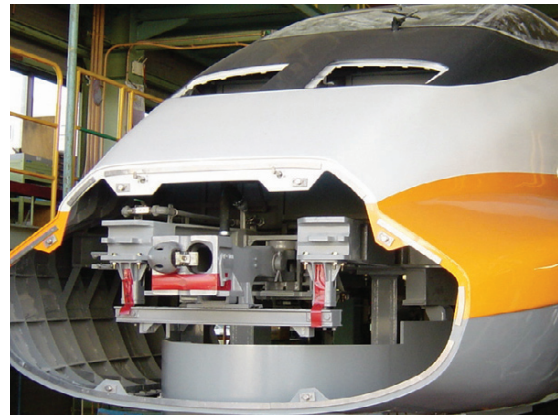
▼Shinkansen Tight Coupler

- In high speed rail cars, repeated impact of the rail coupling causes the nut to loosen and may even risk detachment. Damage to friction ring also causes the nut to loosen.

Major Loosening Causes

- Loosening due to cyclic stress in the direction of the bolt axis
- Loosening due to cyclic stress in the direction perpendicular of the bolt axis

- By using the HARDLOCK Nut, even under repeated impact, loosening is prevented and detachment does not occur. Breakage of the friction ring is eliminated by using the HARDLOCK Nut and has been adopted by many rail car manufacturers.

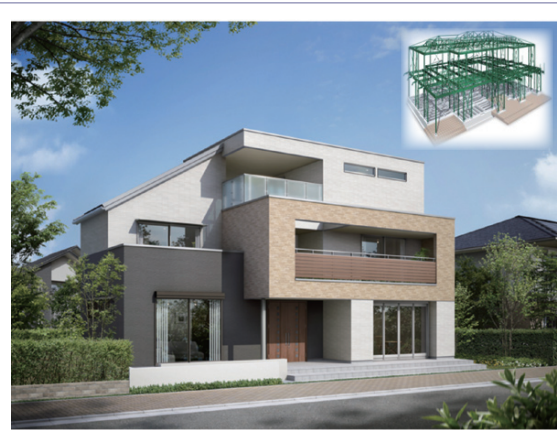
HLN Light-gauge steel frame joints for Detached housing

- Conventionally, based on the Building Standards Law, Single Nuts and Spring Washers was going to be used in the Light-gauge Steel Joint as a countermeasure for loosening.

Major Loosening Causes

- Loosening due to cyclic stress in the direction of the bolt axis
- Loosening due to cyclic stress in the direction perpendicular of the bolt axis

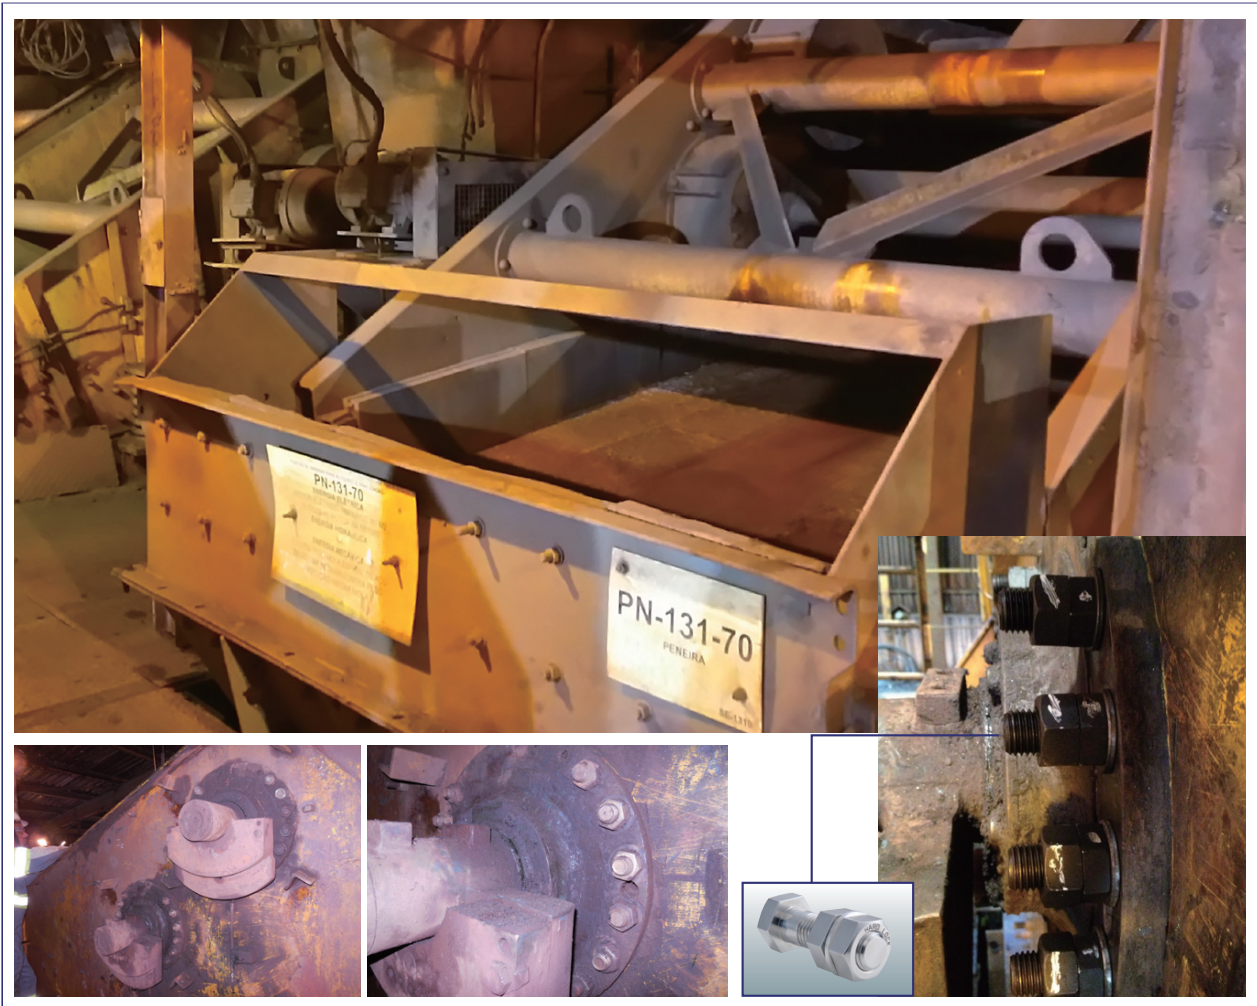
Pendulum Fastening for Vibration Screens

Major Loosening Cause

- Loosening due to cyclic stress in the direction perpendicular of the bolts axis
